# Moorehead Electric Co. Inc.

## Infrared Inspection Report Sheet

Report 2  
Page # 01

Customer: <b>SAMPLE REPORT</b>	Date:	Location of Item Inspected: <b>Boiler Room</b>	<b>Priority Codes:</b>	Reference Item: <b>C-Phase</b>
Item Inspected: <b>AHU Switch #2</b>

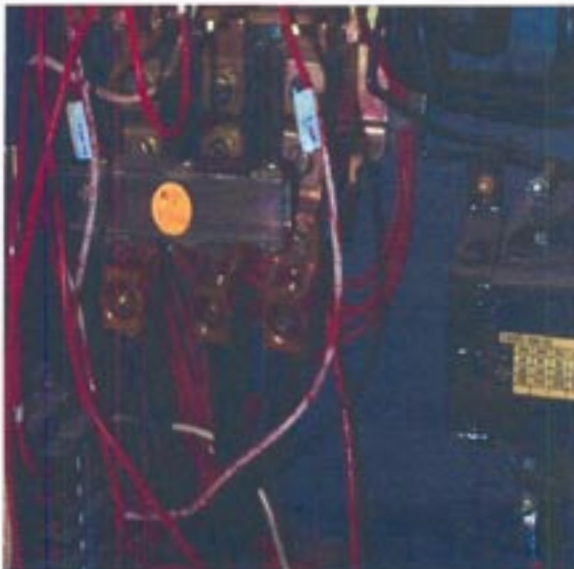
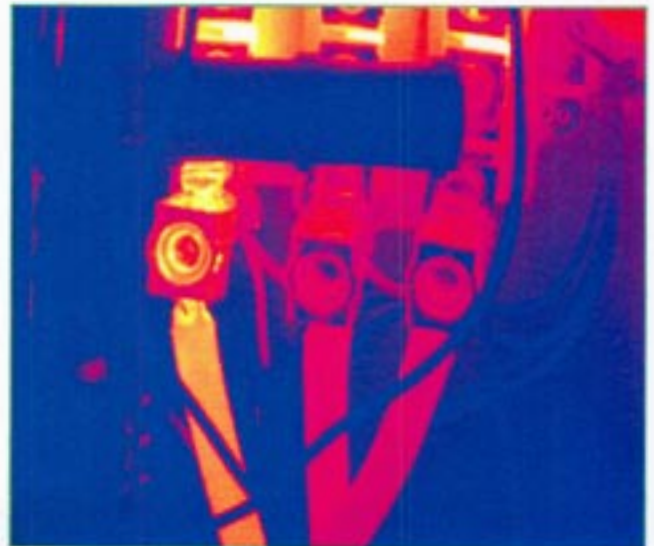
Level 1	Problem/source Temp In Degrees
			Level 2	<b>154°</b>
			Level 3	Reference Temp.: In Degrees
Problem/Reference Description or Opinion:  <b>Heating at A-Phase load side of contactor.</b>				<b>125°</b>
Recommendation For Repair:  <b>Check to see why A-phase has a significantly higher load.</b>				Temperature Rise: In Degrees F.  <b>29°</b>

L-1 =	70	Amps
L-2 =	N/A	Amps
L-3 =	49	Amps
L-4 =	N/A	Amps

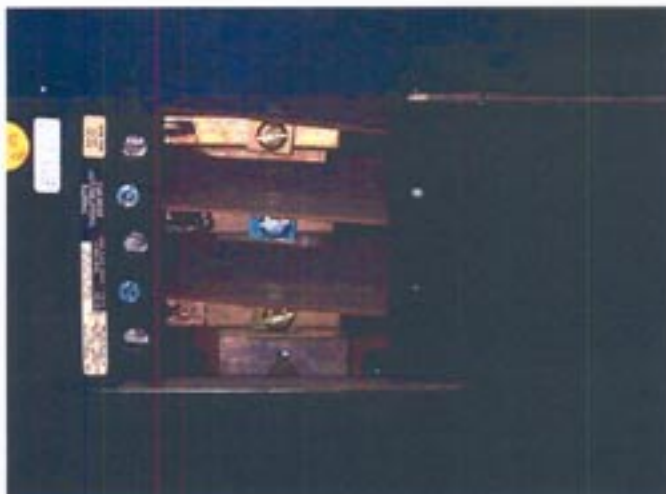
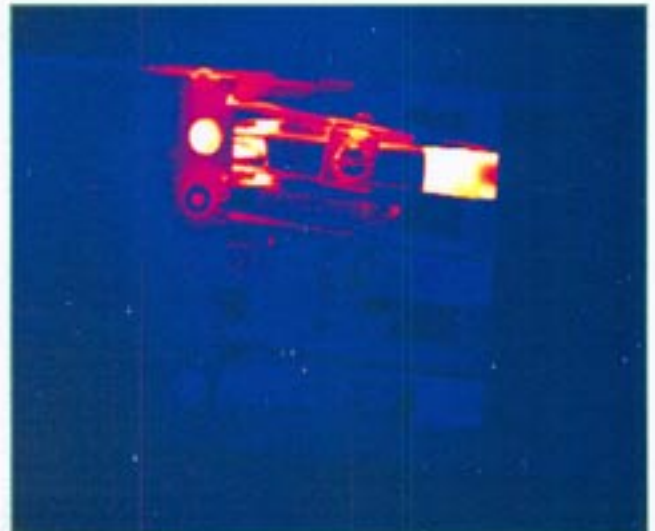
Level 1	Problem/source Temp In Degrees
Problem/Reference Description or Opinion: <b>Heating at A-phase line side of breaker.</b>			Level 2	<b>149°</b>
			Level 3	Reference Temp: In Degrees
Recommendation For Repair: <b>Disassemble, clean contact points, reassemble and torque.</b>		Component Current Rating: <b>100 AMP</b>		Temperature Rise: In Degrees F.
		RMS Current Draw:		<b>49°</b>
		L-1 = 20.6 Amps		
		L-2 = 19.3 Amps		
		L-3 = 21.0 Amps		
		L-4 = N/A Amps		
<b><u>Corrective Actions Performed:</u></b>				
Date Repaired:	Actions Taken:		Component Current Rating:	
Repaired By:			L-1 = N/A %	L-2 = N/A %
